**DEPARTMENT OF TRANSPORTATION**

Contract #: 04-0120F4Cty: SF/ALA Rte: 80 PM: 13.2/13.9File #: 1.28**WELDING INSPECTION REPORT****Resident Engineer:** Casey, William**Address:** 333 Burma Road**City:** Oakland, CA 94607**Report No:** WIR-028611**Date Inspected:** 17-Oct-2012**Project Name:** SAS Superstructure**OSM Arrival Time:** 700**Prime Contractor:** American Bridge/Fluor Enterprises, a JV**OSM Departure Time:** 1730**Contractor:** American Bridge/Fluor Enterprises, a JV**Location:** Job site**CWI Name:** As Mentioned Below**CWI Present:** Yes No**Inspected CWI report:** Yes No N/A**Rod Oven in Use:** Yes No N/A**Electrode to specification:** Yes No N/A**Weld Procedures Followed:** Yes No N/A**Qualified Welders:** Yes No N/A**Verified Joint Fit-up:** Yes No N/A**Approved Drawings:** Yes No N/A**Approved WPS:** Yes No N/A**Delayed / Cancelled:** Yes No N/A**Bridge No:** 34-0006**Component:** OBG**Summary of Items Observed:**

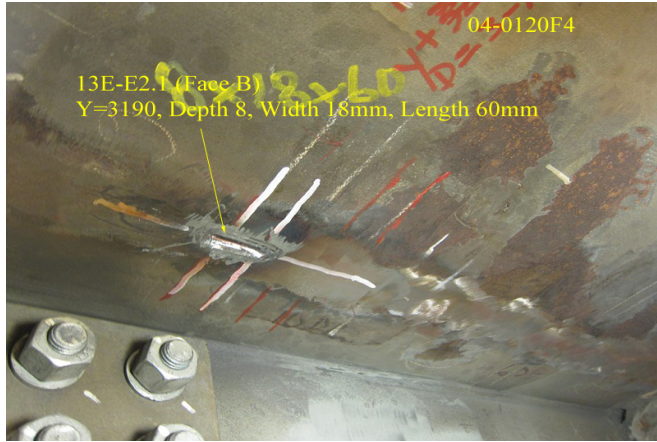
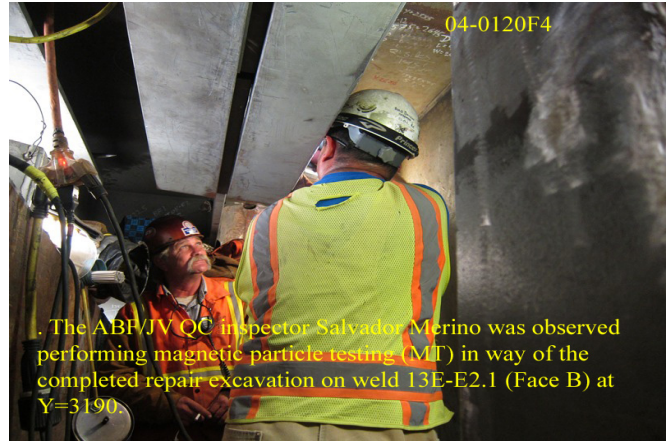
The QAI noted and periodically observed ABF/JV welder Eric Sparks #3040 performing Carbon Arc Gouging (CAG) for the repair of the deck drop-in longitudinal splice designated as 13E-E2.1 from Face B. The QAI was present during the gouging process and observed porosity in the weld at a depth of approximately 4mm. The ABF/JV QC inspector Salvador Merino was observed performing magnetic particle testing (MT) in way of the completed repair excavation at the following locations,

for the repair of the floor beam web splice at panel point 121 at E2. The ABF/JV QC inspector Chris Conche was observed performing magnetic particle testing (MT) in way of the completed repair excavation at the following locations,

The QAI noted and periodically observed ABF/JV welder Wai Kit Lai performing Carbon Arc Gouging (CAG) for the repair of the floor beam web splice at panel point 120 at E2. The ABF/JV QC inspector Chris Conche was observed performing magnetic particle testing (MT) in way of the completed repair excavation at the following locations,

The ABF welder Wai Kit Lai was observed later in the shift performing Shielded Metal Arc Welding (SMAW) in the 4G position utilizing the Caltrans approved Welding Procedure Specifications ABF-WPS-D1.5-1000-Repair. The weld and surrounding area was brought to a temperature of 325°F by the use of induction heaters and maintained throughout the welding process. The repairs were then observed to be post heated at 450°F for one hour as required by the applicable repair document. The repair was performed in accordance with the approval for repair document RWR201209-138.

The ABF welder Rick Clayborn #2773 was observed later in the shift performing Shielded Metal Arc Welding (SMAW) in the 2G/3G position utilizing the Caltrans approved Welding Procedure Specifications ABF-WPS-D1.5-1000-Repair at the above mentioned location. The weld and surrounding area was brought to temperature by the use of a gas torch and maintained throughout the welding process. The repairs were performed in accordance with the following approval for repair documents however; an error in the listed Welding Procedure Specification was noted in the repair document prior to repair, and a change to the applicable welding procedure was made in the field to suit. The QA Task leader was verbally notified of the change for further discussion with the Caltrans Structural Materials Representative (SMR) and ABF Management.

The ABF welder Wai Kit Lai was observed later in the shift performing Shielded Metal Arc Welding (SMAW) in the 2G position utilizing the Caltrans approved Welding Procedure Specifications ABF-WPS-D1.5-1004-Repair. The weld and surrounding area was brought to a temperature of 325°F by the use of induction heaters and maintained throughout the welding process. The repairs were then observed to be post heated at 450°F for one hour as required by the applicable repair document. The repair was performed in accordance with the approval for repair document RWR201209-117.
